Article

Kinematics and Controlling Factors of Slow-Moving Landslides in Central Texas: A Multisource Data Fusion Approach

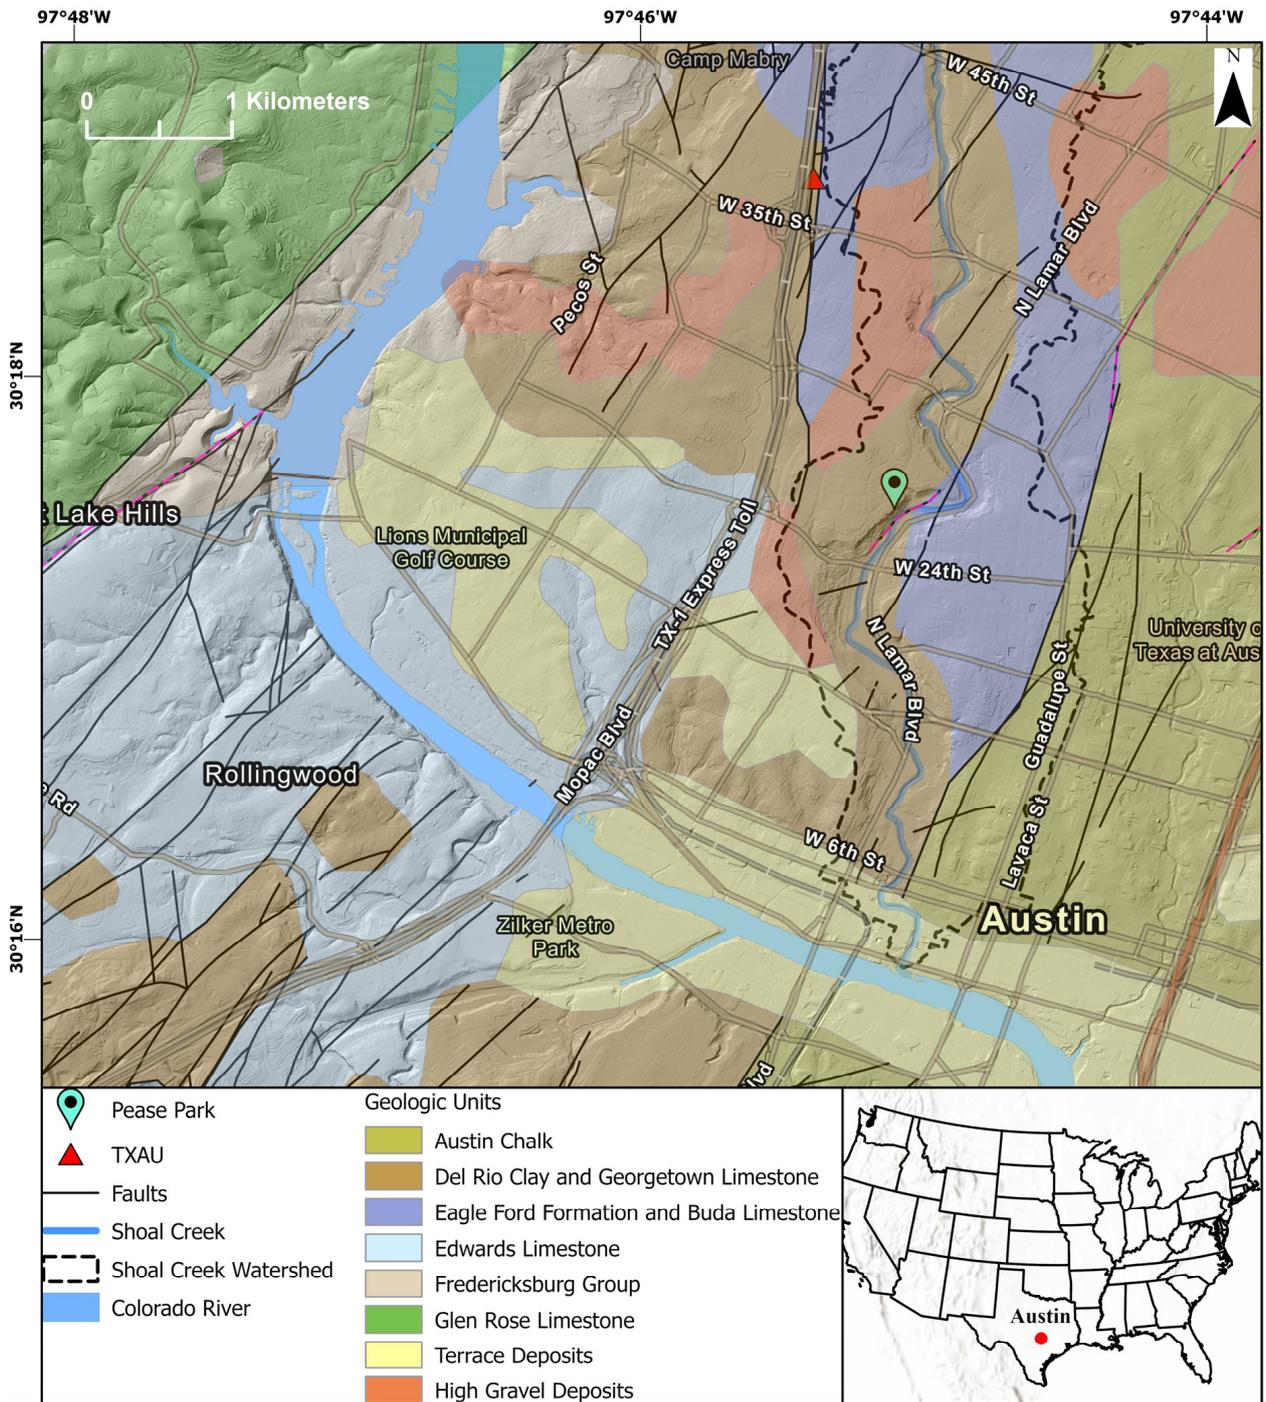
Figure 1. Geographic and geologic setting of the study area. Also shown are Pease Park (light blue pin), where recent landslides occurred, Shoal Creek and its watershed (blue and dashed black line, respectively), the Colorado River, and the TXAU GNSS station (red triangle).

The study investigates sections of the city of Austin and its surrounding areas in Travis County in Central Texas (Figure 1). The Greater Austin Metropolitan Area has experienced unprecedented growth in the past decade and is currently inhabited by over 2 million people [36]. Like other regions worldwide facing rapid population growth and urbanization, factors that amplify hazard susceptibility [37], the high rate of population growth in the Austin metropolitan area has resulted in the expansion of communities into naturally hazard-prone areas [36,38]. Moreover, the population and economic growth in the metropolitan area have led to intensified anthropogenic activities and associated changes, exacerbating the risks of natural hazards, particularly slope failures, on the community and the environment. Two major landslide events that occurred near residential properties in the same location in the Pease Park area of Austin, along Shoal Creek, in May 2018 and May 2019 (Figures 1 and 2) demonstrated the increasing susceptibility of communities to the hazard [39]. Multitemporal imagery of the impacted area, accessible through the time-lapse feature on the open-access Google Earth app (<https://earth.google.com/>, accessed on 20 November 2022), revealed that the area has undergone significant anthropogenic changes, including new property development, expansion, modifications to existing properties, and road construction over the past few decades. The landslides consequently caused damage to both public and private property and the surrounding environment, which are projected to cost the city substantial investment (more than \$20 million) for repair and mitigation efforts [39].

The Balcones Fault Zone (BFZ) represents the main structural feature in the study area. It consists of a system of normal faults that strike NE–SW and predominantly dip southeastward (Figure 1). This fault zone, which is no longer active, occurs at the western boundary of the study area and in areas close to Shoal Creek, exerting primary control over the spatial distribution of rock formations (Figure 1) [41].

Within the study area, the predominant geological formations are sedimentary rocks, ranging in age from the Early to Late Cretaceous (Figure 1). Additionally, unconsolidated Quaternary sediments such as terrace and alluvial deposits are common. The rock formations found on the eastern, downthrown side of the fault zone (in the study area) are Upper Cretaceous shales and chinks that dip gently to the east, including the Eagle Ford Shale and Austin Chalk. The western, upthrown fault block is composed of Lower Cretaceous limestones, including the Glen Rose, and the Edwards and Walnut formations (Fredericksburg Group) (Figure 1). These limestones mainly consist of hard limestone layers interbedded with softer marly/clay-rich layers [41–44].

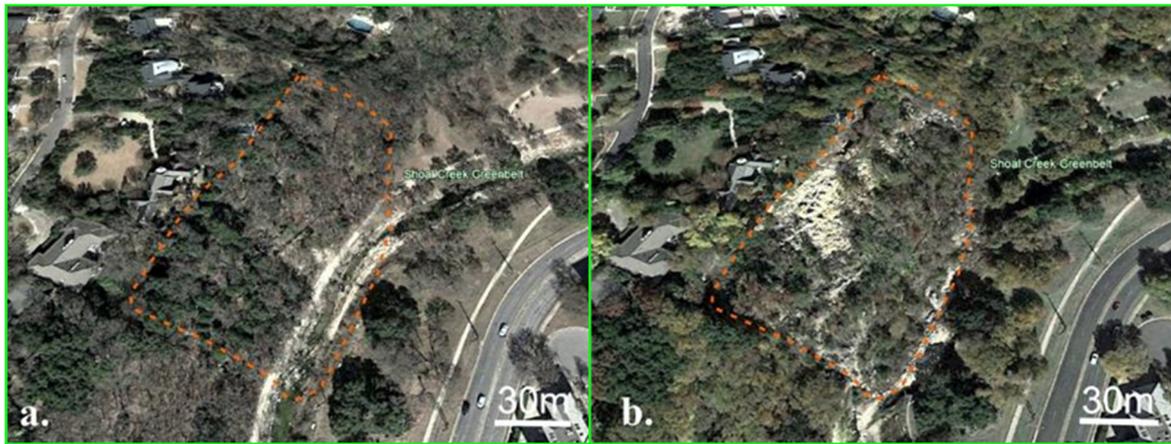
Figure 2. Google Earth images of the Pease Park slope failure site (shown in dashed orange lines) (a) before and (b) after the first slope failure event (2018).

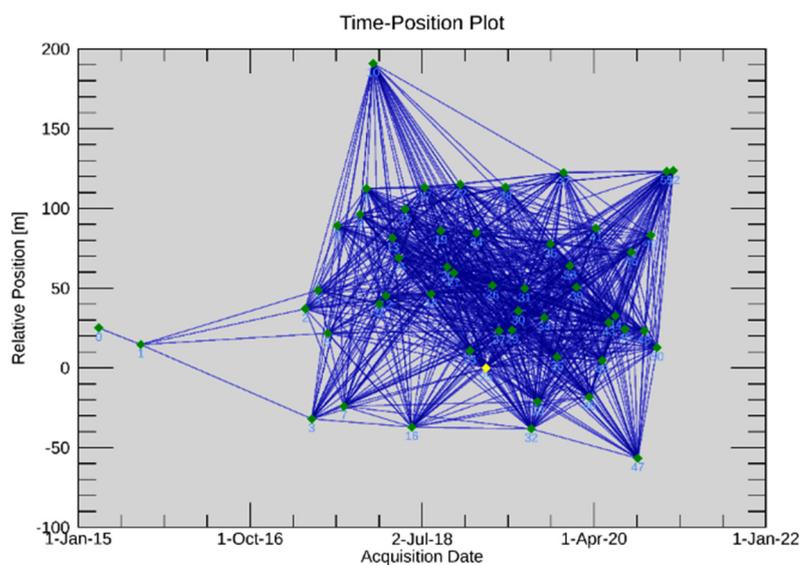
Figure 3. Time–position plot illustrating the temporal and spatial baseline information of the SAR image combinations (shown as green markers).

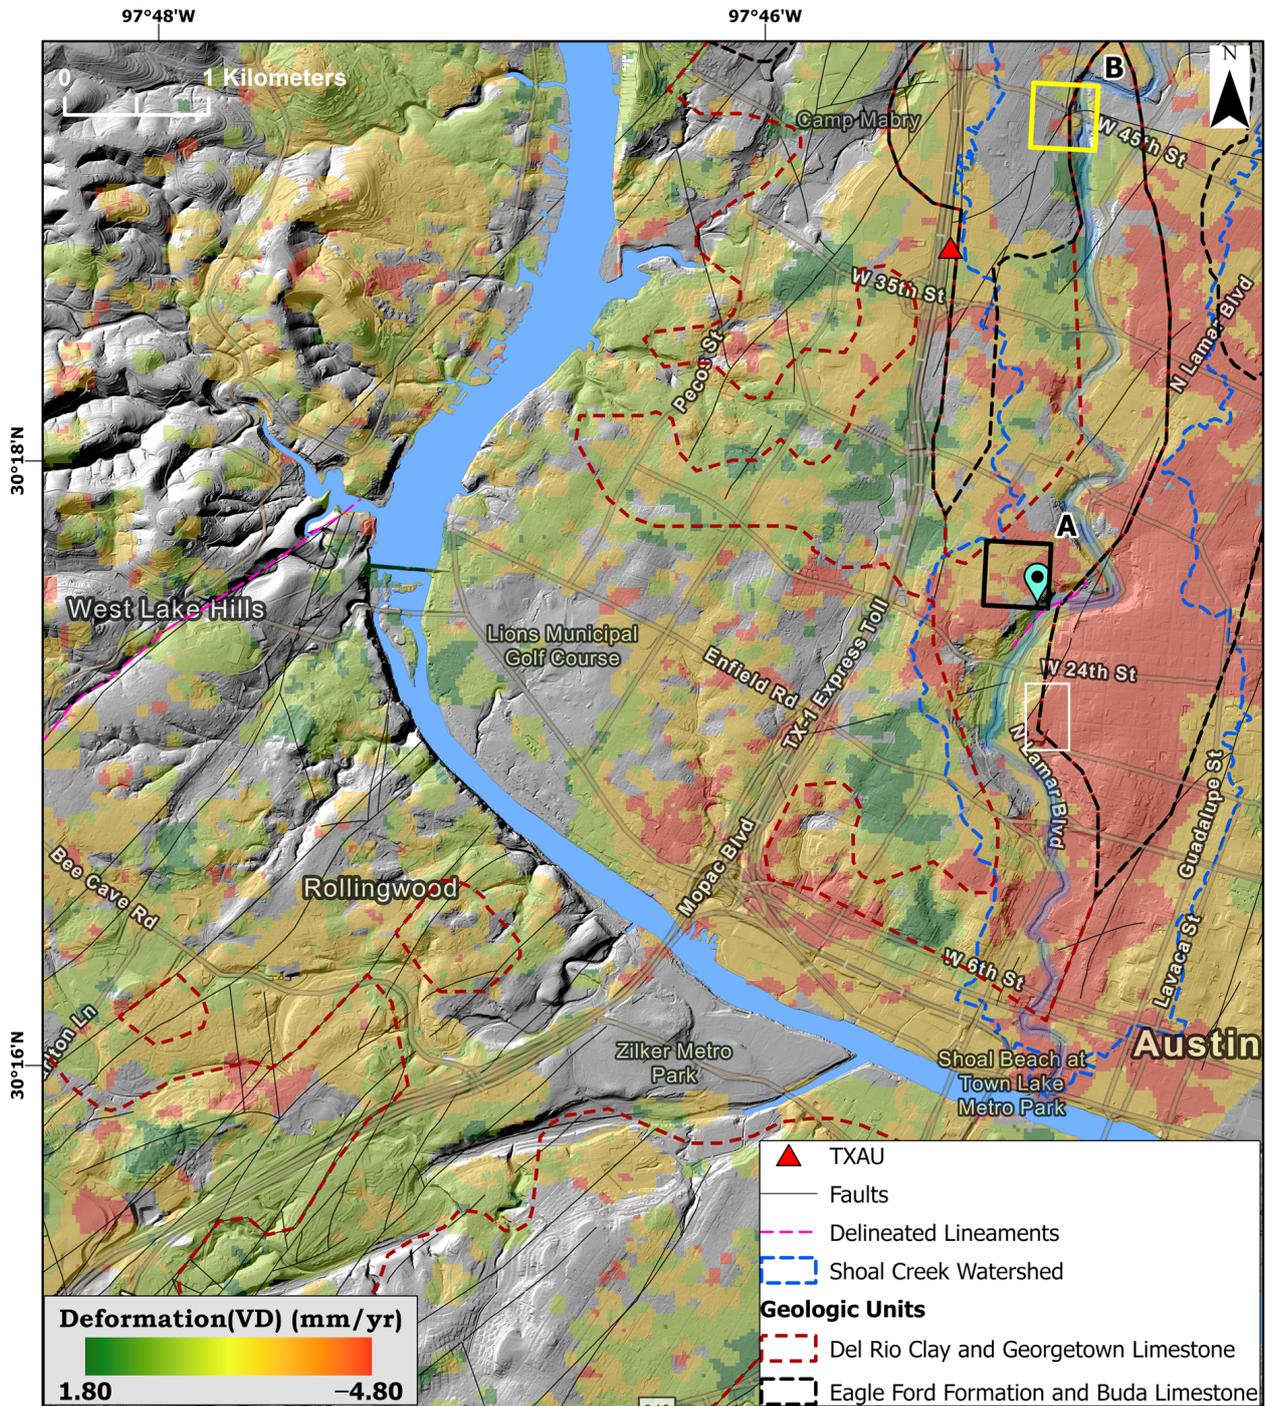
Figure 4. VD displacement rate (mm/yr) in the study area determined using the SBAS technique. The landslide site in the Pease Park (where multitemporal GNSS surveys were conducted), as well as another site investigated during the field survey, is represented by black-outlined (A) and yellow-outlined (B) polygons, respectively.

The majority of the study area (~68%) exhibits deformation rates ranging from -2 mm/yr to $+1.8$ mm/yr (Figure 4). These rates correspond spatially with the distribution of the Lower Cretaceous Edwards and Glen Rose limestones as well as the Upper Cretaceous Austin Chalk (Figures 1 and 4). Relatively moderate rates of hillslope deformation (-2 to -3.91 mm/yr) were observed at several locations along the cliffs of Shoal Creek, primarily composed of the Del Rio Clay (indicated by the dashed brown polygon in Figure 4) with a thin overlay of Buda Limestone. Pockets of relatively high deforma-

tion rates (up to -4.29 mm/yr; Figure 4) were observed in the cliffs opposite Shoal Creek (near North Lamar Boulevard), where the dominant geological formation is the Eagle Ford, overlaying the Buda Formation (indicated by the dashed black polygon in Figure 4). Deformation rates up to -4.4 mm/yr were observed in the central/downtown Austin City area. This area is underlain by the Eagle Ford Formation and Buda Limestone, containing clastic and clay layers (Figures 1 and 4). As observed in many urban settings underlain by clastic/recent sediments and weak units, the relatively moderate to high deformation rates observed in these areas could be attributed to compaction-induced deformation (or changes in the morphology of weak units) resulting from increased stress and loading applied to the ground surface from buildings and other artificial structures [69]. Small clusters (some as small as under 100 m²) exhibiting relatively high deformation rates (up to <-4.8 mm/yr) (Figure 4) were detected in the northeastern and central parts of the study area. During field investigation of several randomly chosen sites located outside the Shoal Creek area and undergoing relatively high deformation rates (e.g., area depicted by the white-outlined polygon in Figure 4), it was observed that new property development was ongoing or recently completed, as evidenced by time-lapse imagery of an area in Google Earth Pro from 2017 to 2021 (Figure 5). The observed relatively high deformation rates in these areas may be linked to accelerated compaction of newly added soil material for construction projects. These findings suggest that not all displacement signals shown in Figure 4 can be solely attributed to active landslide processes.

(Figures 1 and 4) were estimated using the RTK GNSS measurement technique during two field campaigns: one in August 2021 and another in March 2022. The analysis of the multitemporal campaign GNSS data indicated that the hillslope is undergoing active and relatively high deformation activity (up to -17 mm/month). It is important to note that the March 2022 RTK GNSS campaign was conducted under dense cloud cover conditions and following an intense rainfall event the previous day, which caused slight movement of the landslide debris downslope and resulted in accessibility issues at all but one of the sites from the August 2021 RTK GNSS campaign. The results showed a relatively higher deformation rate (up to -17 mm/month) than that reported by the SBAS analysis (of nearby pixels); however, this can be attributed partially to the effect of clouds or precipitation on the GNSS signal [79] during the second measurement, a displacement rate accelerated by the intense precipitation episode in the days before the field visit, or the relatively short duration of the investigation. Nonetheless, these results demonstrated ongoing activity in the area, as depicted by the SBAS pixels from nearby sites (Box A in Figure 4).

This assessment consolidates the notion that slope materials in the study area undergoing deformation at a rate of less than -2 mm/yr, as indicated by the SBAS result (Figure 4), are likely experiencing active slow-moving landslide activity. This activity could eventually culminate in slope failure if triggering events occur and conditions for the controlling factors are met.

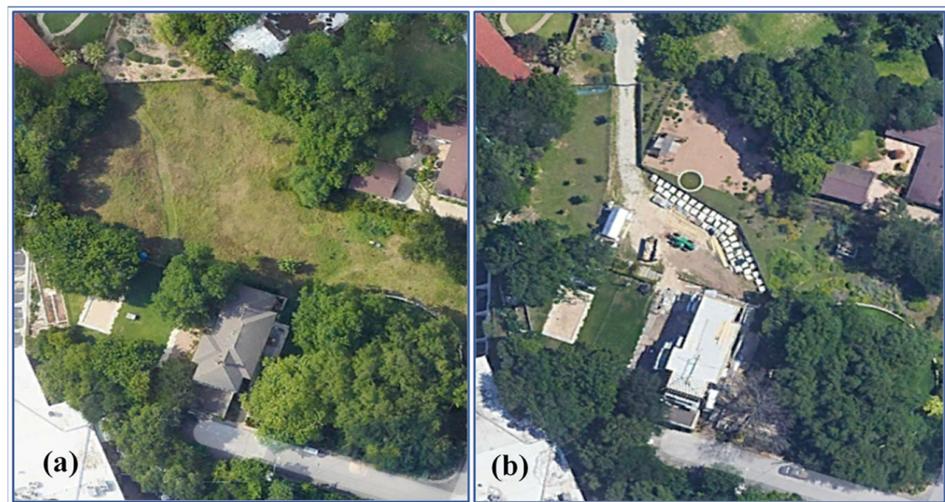
Figure 5. Time-lapse imagery ((a): February 2017; (b): June 2021) of an area (shown in a white-outlined polygon in Figure 4) undergoing deformation at a rate of -4.2 mm/yr, attributed to other (non-landslide) processes.

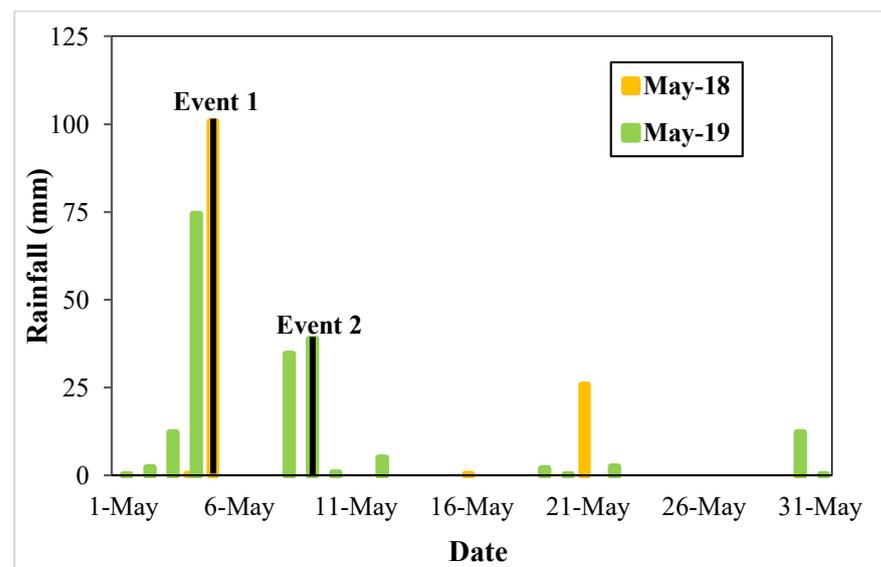
Figure 6. Graph showing the daily precipitation records for May 2018 (shown in yellow) and May 2019 (shown in green). Also shown are the onset times of the landslide events (events 1 and 2).

A segment of Shoal Creek, specifically a site in the Pease Park area (shown in blue pin in Figure 4), has experienced two consecutive rotational landslide events in recent years following heavy rainfall episodes [74,75]. The first event, which caused significant displacement approximately 300 feet in length [74], occurred in May 2018, followed by a minor debris movement the following year in May 2019 [75]. The daily precipitation records for May in both 2018 and 2019 (Figure 6), obtained from a station (ID: GHCND:US1TXTV0044; source: National Environmental Satellite, Data, and Information Service (<https://www.ncei.noaa.gov/>, accessed on 1 March 2024) located near Pease Park in the Shoal Creek area, indicate the prevalence of relatively high daily rainfall totals (up to 101 mm in the case of the May 2018 event) before the onset of debris movement along Pease Park (Figure 6). Historical records also provide evidence of similar slope failures occurring in various sections of the Shoal Creek area decades before the recent events [76].

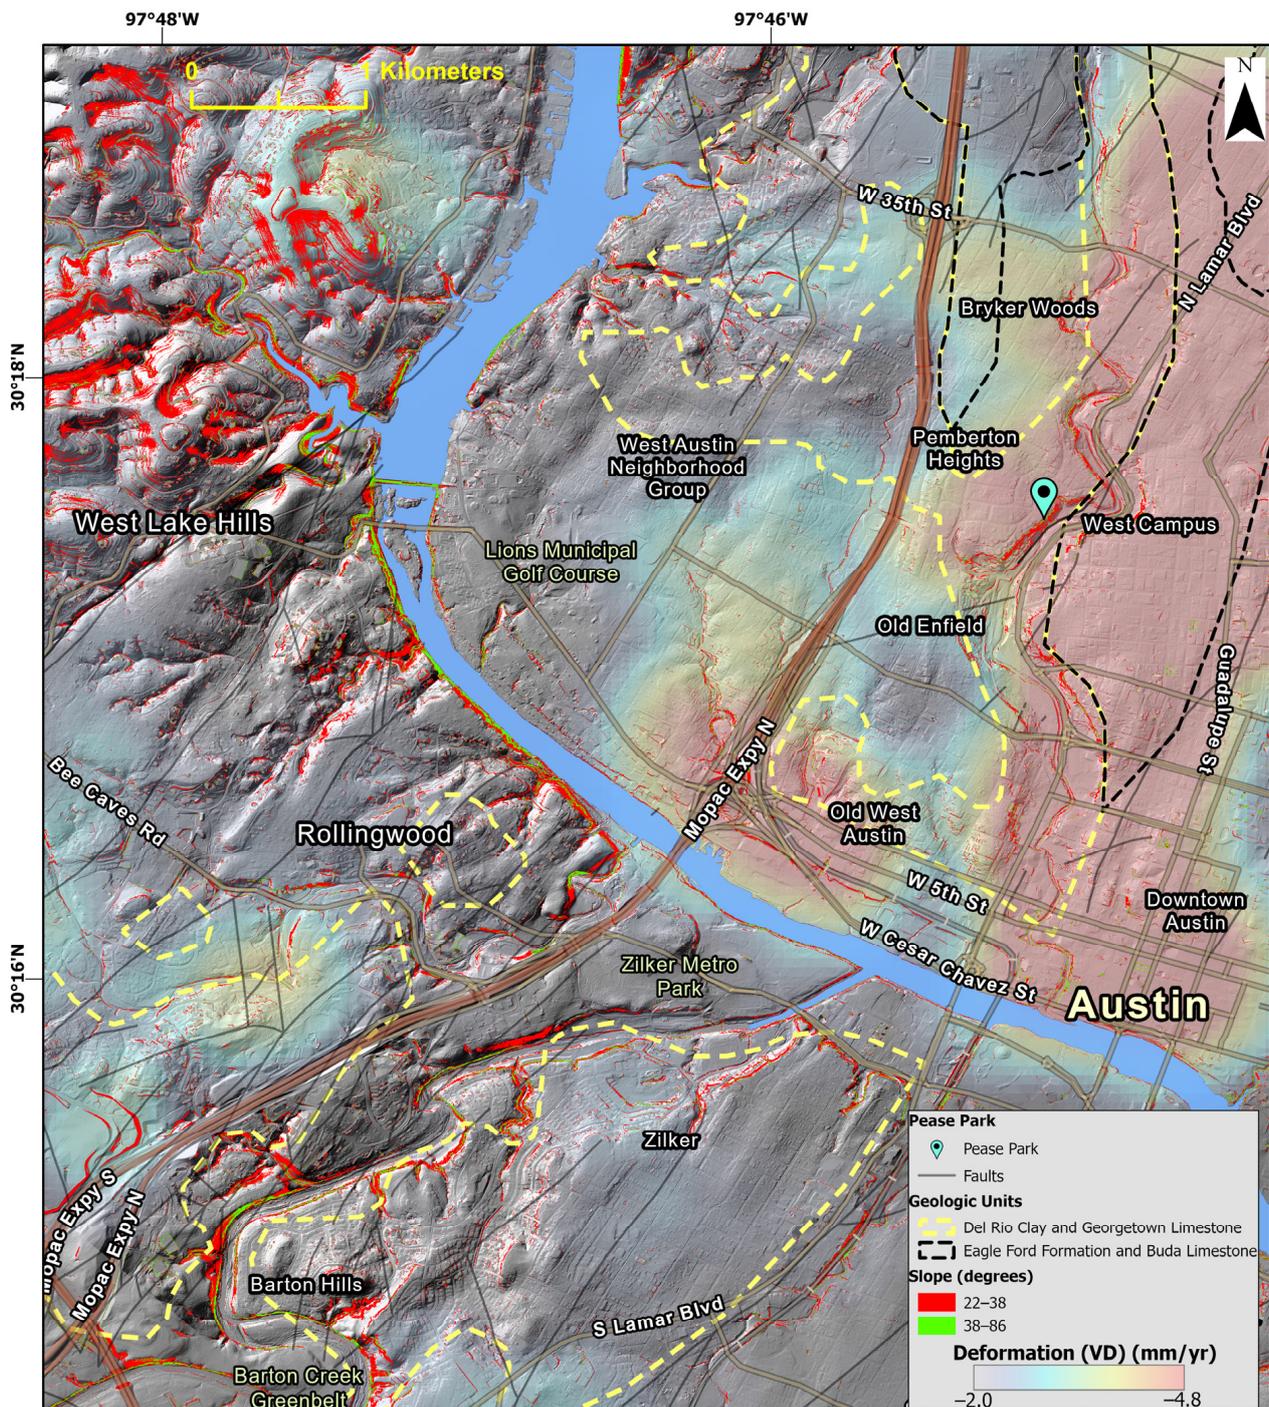
Figure 7. Slope (in degrees $^{\circ}$), geology, and faults superimposed on the deformation (<-2 mm/yr) density distribution map to identify the processes and factors that control the incidence of slow-moving landslides in the study area.

A slope map, generated using the LiDAR DEM data (Figure 7), revealed gradient angles ranging from 0° to 86° . Elevations over 96% of the study area exhibit a maximum slope gradient of 22° . According to Highland and Bobrowsky [7] and Zhang et al. [80], slow-moving landslides such as slides and creeps are common in slope angles ranging approximately between 20° and 50° . Hence, for examining the spatial relationship between relatively moderate to steep slope topography and slow-moving landslides in the study area, slope angles falling within the ranges of 22 – 38° and greater than 38° were isolated from the classes of slope angles obtained using the natural break classification (Figure 7). These categories constitute approximately 3.21% and 0.64% of the slope values within the study area, respectively. Within the Shoal Creek Watershed, including Pease Park, more than 81% of the area is characterized by the relatively moderate slope angle class (22 – 38°). North of the Balcones Escarpment (Figure 7), both relatively moderate and steep slope values (exceeding 38°) were observed. Steep slope gradients were also noted in certain pockets along the Barton Creek area (southwestern part of the study area) and in proximity to the Colorado River pathways (Figure 7).

There is a spatial correlation between the (negative) VD deformation patterns, signifying slow-moving active landslides (<-2 mm/yr), and moderate to steep slope values ($>22^{\circ}$) in most terrains along Shoal Creek and to the north of the Colorado River in general (Figure 6). However, not all terrain with moderate to steep slopes may potentially experience slope failure incidents (Figure 7).

For example, the steep slope terrains north of the Balcones Escarpment (north of West Lake Hills [Figure 7]) exhibit some of the highest slope gradient values observed in the

study area ($>60^\circ$); however, they are not undergoing any significant and large-scale active displacement, per the SBAS-based deformation assessment, as areas along the downstream sections of the Colorado River (Figures 4 and 7).

Most of the moderately to steeply sloping terrains undergoing active displacement in the study area are underlain by the Eagle Ford and the Del Rio formations (Figure 7) and are dissected by or located proximal to faults belonging mostly to the Balcones Fault System. These facts indicate that geology and tectonic features, coupled with moderate to steep slope terrain conditions, are the leading controls for the incidence of landslides in the study area.

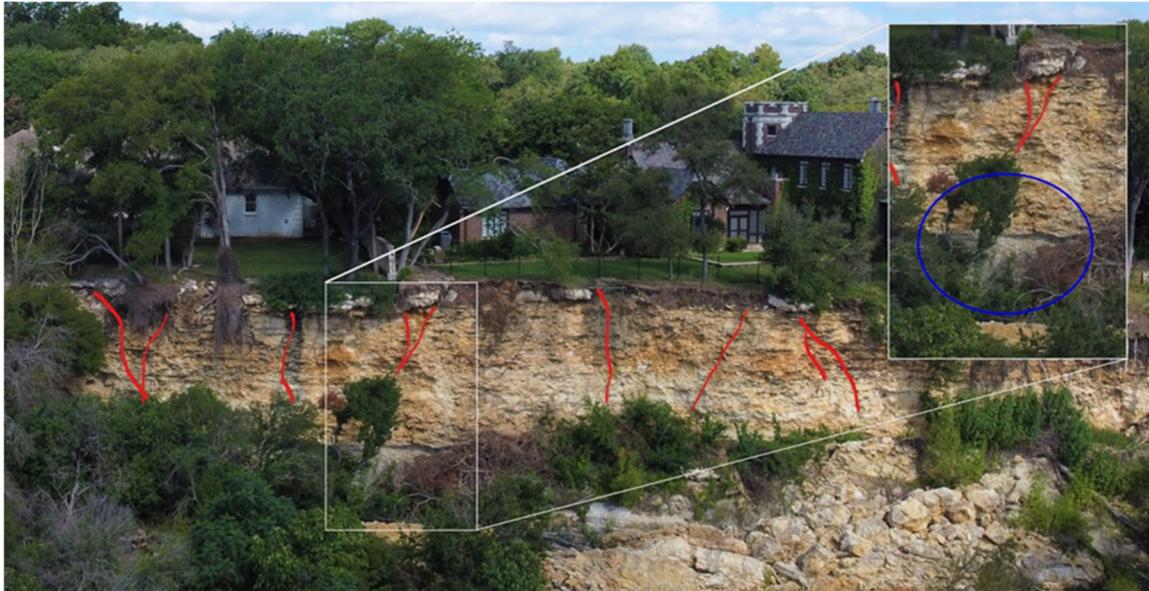
Figure 8. 3D model of the Pease Park (Shoal Creek) landslide. The inset on the right side provides a close-up view of the contact between the Buda Limestone and the Del Rio layer, which acts as a slip surface. Several fracture pathways within the Buda Limestone, through which surface water may have percolated into the subsurface and interacted with the Del Rio Clay layer, are depicted in red.

A careful examination of the landslide geometry at Pease Park was made possible through the utilization of a 3D model of the cliff and its surroundings, which was generated using datasets acquired by UAV (Figure 8). The analysis revealed a curved and concave rupture surface, scarp, crown, and various other features associated with slumps. Moreover, it demonstrated a shallow failure zone, wherein the overlying Buda unit and underlying

Del Rio unit were found to have shallow contact, indicating that the Del Rio Clay unit functions as a slip surface. Additionally, the figure illustrates potential pathways (depicted by red lines in Figure 8) that could have facilitated the infiltration of precipitation to the underlying Del Rio mudstones during precipitation episodes.

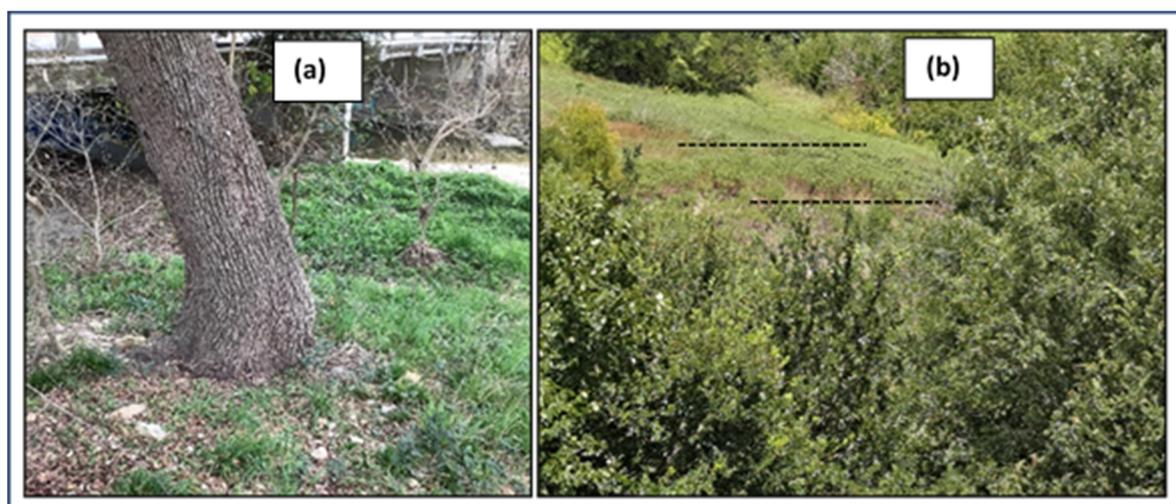
Figure 9. Ongoing landslide process precursory indicators observed at (a) Pease Park and (b) another area within Shoal Creek located nearly two miles from Pease Park (location shown in yellow-outlined polygon in Figure 4).

Precursory surface geomorphic evidence of an active rock creep landslide process, such as holes and dips in the ground [84], had been observed by residents long before the slope failure in the Pease Park area [85]. This observation was further supported by the tilted or bent structure of trees (Figure 9a) encountered during the field investigation in the area.

Additionally, a similar geomorphic pattern, although in the early stages of morphing into a rotational slump, was identified at a location within Shoal Creek (yellow-outlined box (label B) in Figure 4) through an indicator of landslide activity observed during the field investigation. At this site, tension cracks (depicted as dashed black lines in Figure 9b), which are indicative of the initial phases of a shallow rotational slide [35,86], were observed. The site is situated on a moderate slope ($\sim 28^\circ$) and is experiencing deformation of up to -2.29 mm/yr based on the displacement rate of adjacent pixels. Similarly, the cliffs on the opposite side of Shoal Creek which are dominated by the smectite-rich Eagle Ford and dissected by faults (Figure 4) are potential sites of active slow-moving landslide processes. The sites lie at moderate to steep slopes ($>22^\circ$) and move at a VD rate of up to -4.29 mm/yr (Figure 4). Several studies focusing on south and central Texas corroborate this assessment of the susceptibility of cliffs dominated by the Eagle Ford Formation to slow-moving landslides [87–89].
